Manhole Inspection Summary

Manhole # S13II1015MH

Location Address: **4417 PIMLICO RD** Cross Street: **COLD SPRING LN**

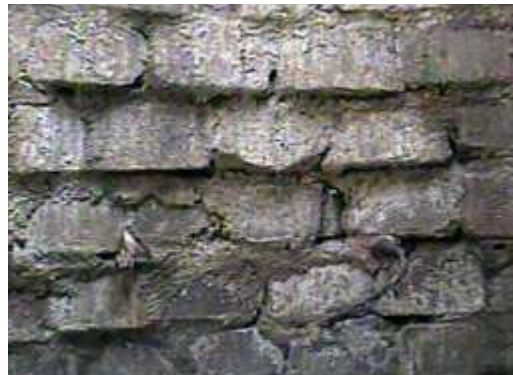
Defect 1

Steps Count: **2** Missing: **2** ☒ **Corroded**

CORRODED/MISSING RUNGS

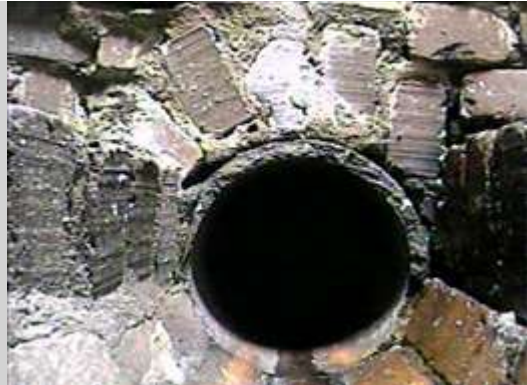
12 O'Clock Outflow

8 in. Circular Gravity Sewer
Pipe Out @ 12 O'Clock

Pipe Height: (in.) Direct (Angled)
Pipe Material: **Clay** ☐ Pipe Lined
Invert Depth: **6.49** (ft.) Flow Characteristics: **Slow**
Deposits: ☒ None ☐ Mud ☐ Sludge ☐ Debris ☐ Grease
Silt Depth: (in.) Deposits Extent:
Infiltration: **None** Pipe Seal Cond: **Sound**

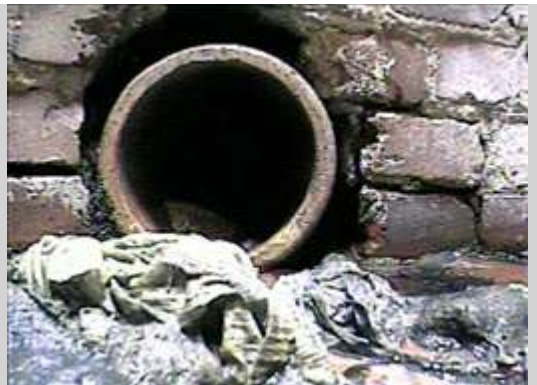
5 O'Clock Inflow

6 in. Circular Gravity Sewer
Pipe In @ 5 O'Clock

Pipe Height: (in.) Direct
Pipe Material: **Clay** ☐ Pipe Lined
Invert Depth: **5.55** (ft.) Flow Characteristics: **None**
Deposits: ☒ None ☐ Mud ☐ Sludge ☐ Debris ☐ Grease
Silt Depth: (in.) Deposits Extent:
Infiltration: **None** Pipe Seal Cond: **Sound**

Connects To: **Stub connection / abandoned**

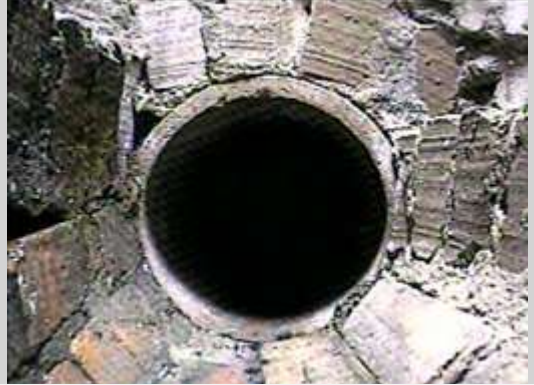
9 O'Clock Inflow

8 in. Circular Gravity Sewer

Pipe In @ 9 O'Clock

Infiltration: **None** Pipe Seal Cond: **Cracked**
